# Manhole Inspection Summary

Manhole # S21C1\_001MH

Insp Date: **5/7/09 9:37 AM**

**Location** Address: **2635 PACA ST**

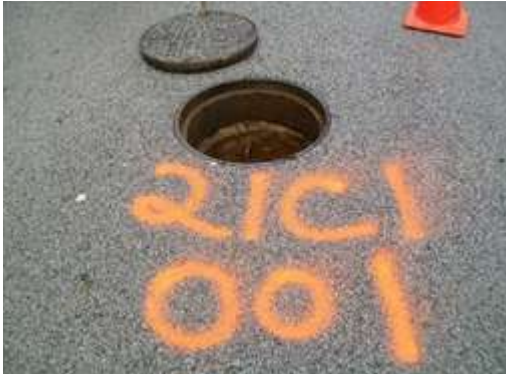
Miscellaneous

PAVEMENT MARKED

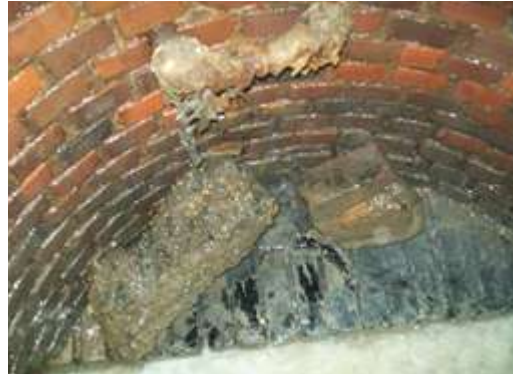
Defect 4

Condition: ☐ Sound ☐ Cracked ☐ Root Intrusion ☐ Deteriorated ☐ Leaks ☒ **Debris**

DEBRIS ON BENCH

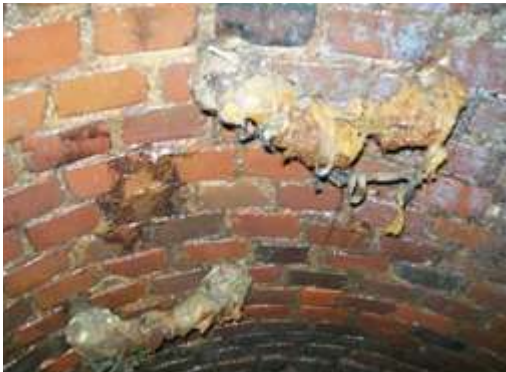
Defect 3

Infiltration: ☐ None ☐ Joint ☐ Cracks ☐ Mortar ☐ Roots ☒ **Wall**

☒ **Evidence Of Surcharge** Depth: **6** (ft.) ☐ Active Surcharge Present

infiltration @ barrel wall; surcharge evidence

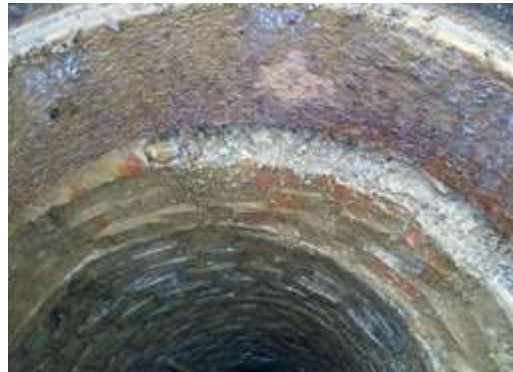
Defect 2

Condition: ☐ Sound ☐ Cracked ☐ Root Intrusion ☐ Loose Brick ☒ **Deteriorated**

Infiltration: ☐ None ☒ **Joint** ☐ Cracks ☐ Mortar ☐ Roots ☐ Wall

DETERIORATED CHIMNEY,  
INFILTRATION AT JOINT

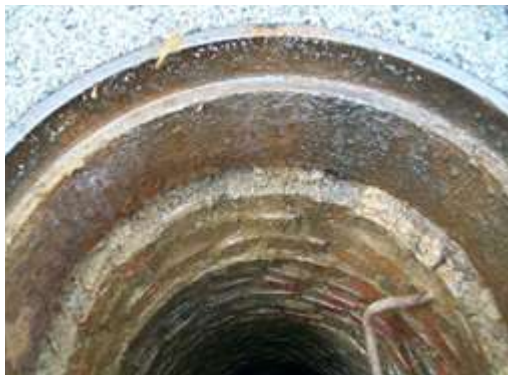
### Defect 1

Offset: **1.5** (in.)

FRAME OFFSET

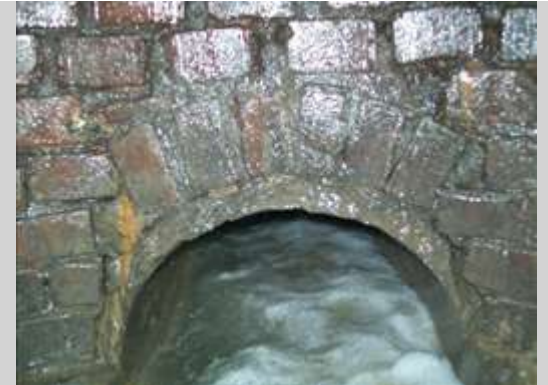
12 O'Clock Outflow

Pipe Height: **18** (in.) Rod and Bar (Angled)  
Pipe Material: **Clay** ☐ Pipe Lined  
Invert Depth: **17.00** (ft.) Flow Characteristics: **Turbulent**  
Deposits: ☒ None ☐ Mud ☐ Sludge ☐ Debris ☐ Grease  
Silt Depth: **0** (in.) Deposits Extent:  
Infiltration: **Evidence** Pipe Seal Cond: **Cracked**

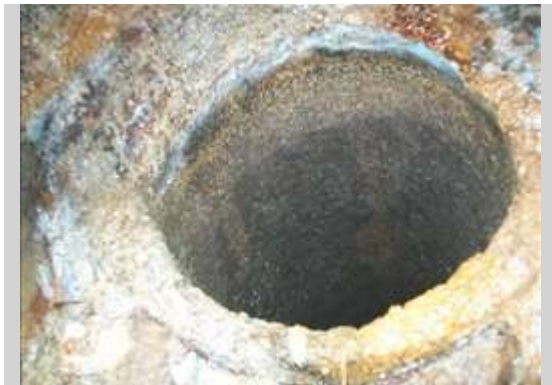
7 O'Clock Inflow

Pipe Height: **18** (in.) Rod and Bar (Angled)  
Pipe Material: **Clay** ☐ Pipe Lined  
Invert Depth: **9.55** (ft.) Flow Characteristics: **Turbulent**  
Deposits: ☒ None ☐ Mud ☐ Sludge ☐ Debris ☐ Grease  
Silt Depth: **0** (in.) Deposits Extent:  
Infiltration: **None** Pipe Seal Cond: **Cracked**

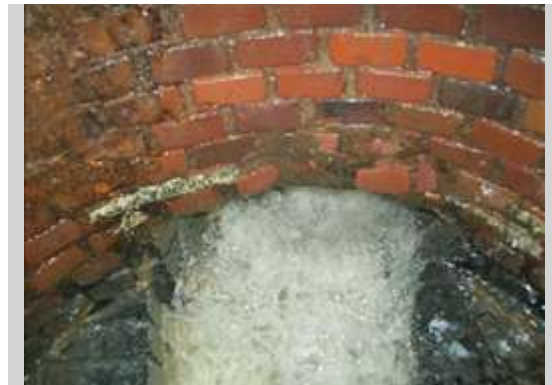
Drop In @ 7 O'Clock

unable to obtain proper pipe picture angle of 7 o'clock due to turbulent flow

Drop: **Outside** Rod and Bar  
Angled: **Yes** Reading: **15.15** (ft.)  
Inv Depth: **16.15** (ft.)  
Drop Condition: **Open**

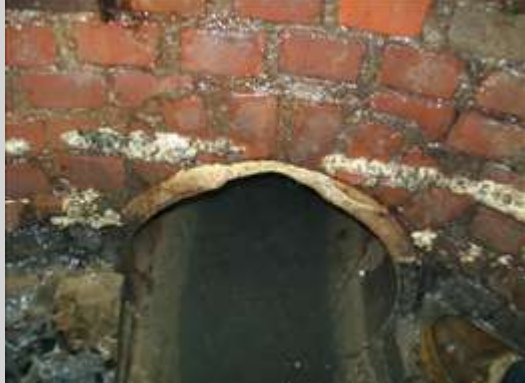
9 O'Clock Inflow

Invert Depth: **16.75** (ft.) Flow Characteristics: **Slow**

Infiltration: **None** Pipe Seal Cond: **Sound**
